# ASNU TIPS

## ASNU and Preserving the GDI Injectors used by VW/Audi, BMW/Bentley/Mini, Ford/Mazda Fiat/Alfa Romeo GM and more

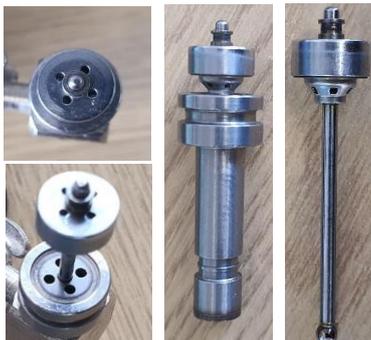
If you look at the pictures below of the pintle section and the holes that the fuel has to flow through, you will understand that if anything blocks one of these holes it can greatly reduce the flow up to 25% if one hole is blocked. If it reaches the second platform, it could also reduce the flow or even worse get caught in the seating at the bottom of the Pintle shaft and either disrupt the spray pattern, cause a leak or even cause the injector to stick wide open, the consequences of any of these could be costly.

This now creates a problem inside the injector where bits of broken nylon are restricting the injectors' operating functions, for example the fuel delivery quantity, the travel of the pintle and the possibility of these particles causing the injector to leak or cause the injector to stick open and cause hydraulic lock.
