# ASNU TIPS

(06/2019)

## Sagem "Mini" Injector

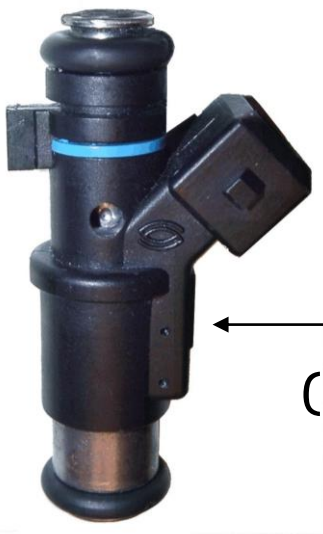
These injectors can suffer with water damage to the internal disc controlling the flow of the injector. This can even be caused by condensation in the fuel tank. Unfortunately, cleaning will not resolve these problems and in some cases it can make the problem worse, so if these injectors show any signs of poor performance, they should be replaced. We recommend a Bosch replacement injector as shown below.

← **Sagem**  
(problem injector)

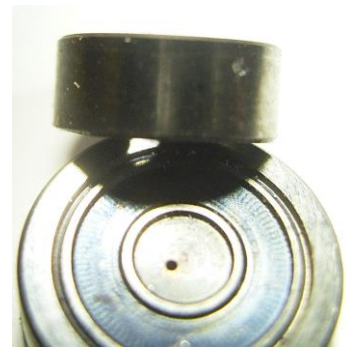
↑  
How the disc  
should look

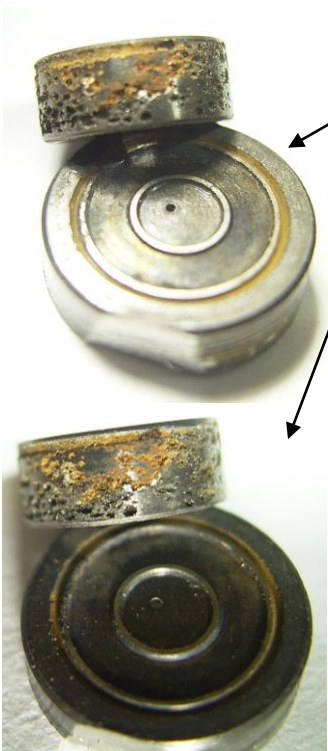
Damage caused  
by water  
contamination

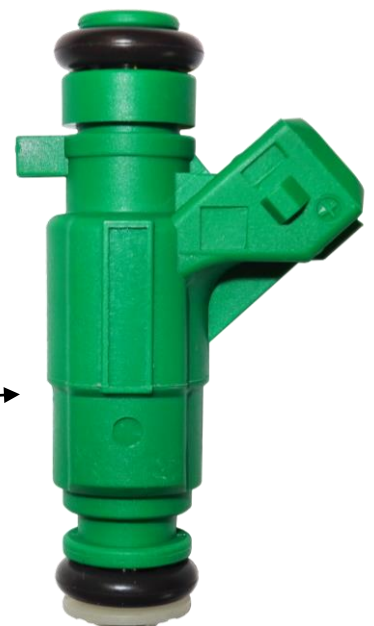
Recommended Bosch  
replacement injector
